# Ceramic Chip Capacitors

## **Application Overview:**

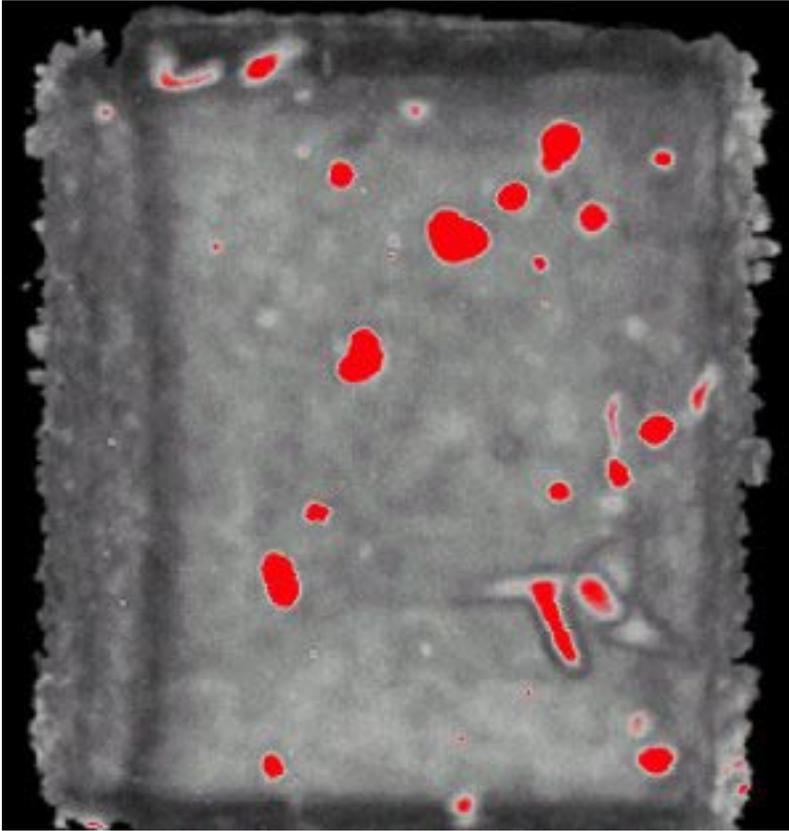
This is a pulse-echo mode image using a 75MHz 12mm focal length. This peak amplitude image utilizes a material scan technique to display information regarding the integrity of the entire capacitor. A color palette adjustment was made so defects appear as red in the image. Delaminations within the dielectric layers appear as large red areas. A elongated void which is likely caused by the baking out of a fibrous or dust particle contaminate can be seen as a curved red object. Voids or any other type of air gap that crosses several dielectric layers can cause an electrical short within the part. Typically acoustic inspection is performed to determine long term capacitor reliability by culling devices with delaminations, large voids, cracks and so forth.

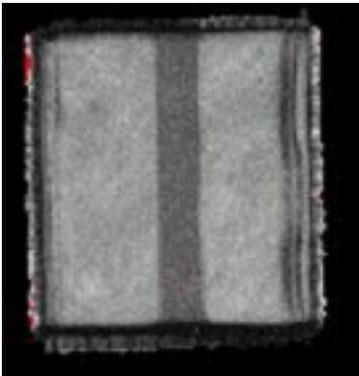
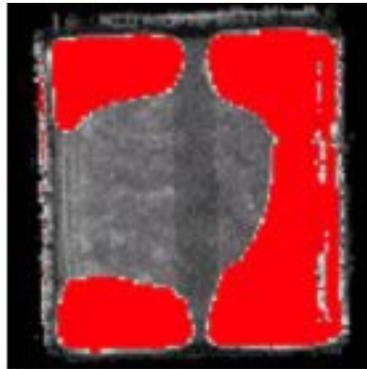
These are pulse-echo (reflected) mode C-scan images using a material scan imaging technique. A 75MHz 12mm focal length transducer was used to create both image. Same as before, the material scan displays information regarding the integrity of the entire capacitor. Both images are of the same capacitor pre and post-stressing. The image on the left was taken at time 0. The image on the right shows significant delamination after 50 hours of electrical and temperature stressing. The dark band down the middle of the capacitor is the result of an area were the alternating dielectric layers within the capacitor overlap. A separation of dielectric layers within the capacitor can seriously impact the electrical reliability of the unit.
