# Flip Chips

## **Application Overview:**

Acoustic inspection of flip chips has become one of the dominant uses of acoustic microscopes. Ensuring adequate underfill flow or inspection for excess flux material is one of the more common applications. Many customers are experimenting with new methods of dispensing underfill or trying to qualify new materials. These firms have found utilizing acoustic inspection an essential tool during product development and failure analysis. Some of the larger volume flip chip manufacturers continue to use SAM technology in a lot qualification or process control role. Inspections can occur on board mounted or loose devices and semi or fully automated inspections are possible.

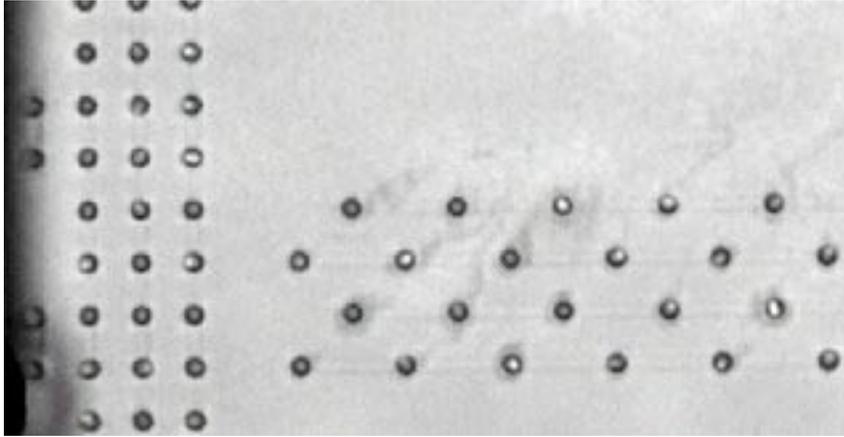
This is a pulse-echo (reflected) mode image of a section of a flip chip package. A UHF 5.9mm focal length transducer was used to create this image. This peak amplitude image displays information regarding the bond quality of the underfill and solder joint to die bond interface. A white area in the center of a solder ball indicates a delaminated electrical

interconnect. This disbonding was likely caused by the solder ball not properly wetting to the bond pad. The delamination may be so thin that the joint will pass electrical testing, but the joint will likely fail later in life. Delaminations as thin as 50 nanometers can be detected in flip chips by SAMs. The darker gray areas noted the location of varying underfill density. The density variation is due to the settling of the larger filler particles contained in the underfill material. These areas, commonly called “flow lines” because the pattern follows the dispensing direction of the underfill and can be considered a reliability concern due to the CTE mismatch they cause.

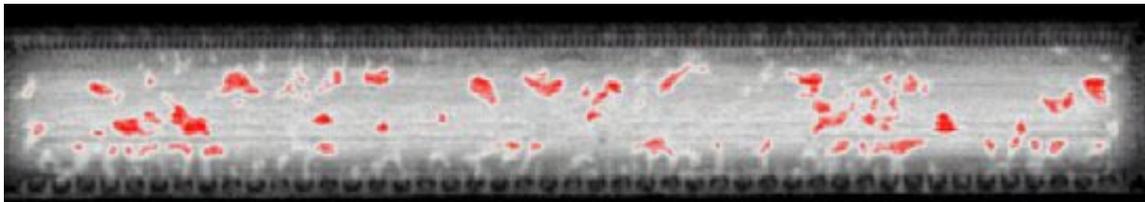
This is a pulse-echo (reflected) mode image of a flip chip bonded to a flex circuit. A UHF 5.9mm focal length transducer was used to create this image. This peak amplitude image displays information regarding the bond quality of the underfill to die and underfill to substrate interfaces. The red areas note the location where the underfill has separated from the die interface. These separations can expand upon stressing and compromise the structural integrity of the solder balls.

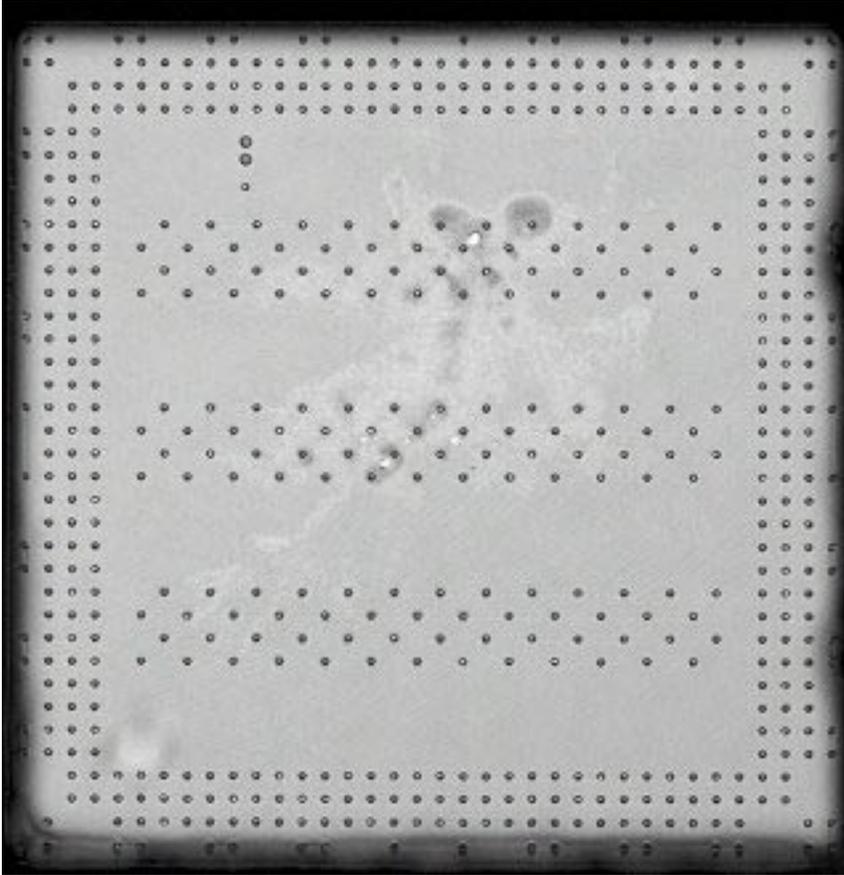
This is a pulse-echo (reflected) mode image of a flip chip package. A UHF 5.9mm focal length transducer was used to create this image. This peak amplitude image displays information regarding the bond quality of the underfill to die and underfill to substrate interfaces. Bright white areas represent disbonds between the underfill and die. A lack of underfill bonding near solder joints can cause the joint to be structurally unsound or cause electrical shorting between interconnects. Underfill delamination is frequently caused by an insufficient amount of

underfill material or inadequate flow of that material underneath the chip or separation caused by part stress. Voids within the underfill are frequently caused by contaminants (like excess flux) or air pockets trapped during the flowing process.
