Metal Ball Grid Arrays

Application Overview:

Like plastic ball grid array devices, SAM inspection of metal BGAs is also very common. The metal lid may make penetrating the device with X-rays more difficult, however assists in getting high resolution images with SAM systems. Lid seal integrity, die attach and lead finger bond quality are the more common inspection performed.

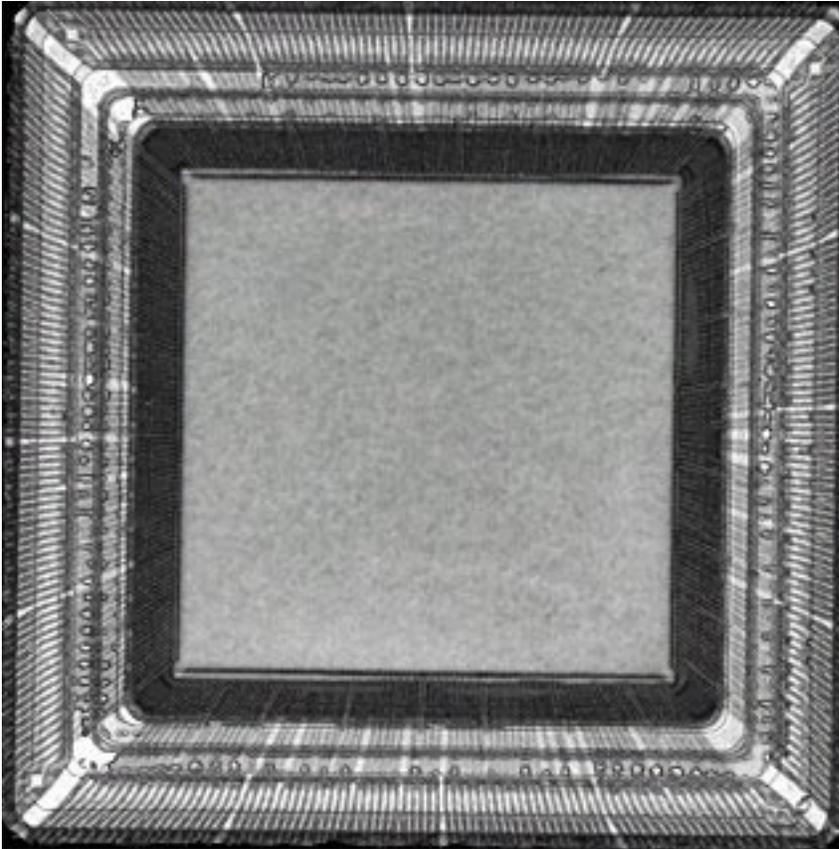
This is a pulse-echo (reflected) mode image of the encapsulant or back side of a metal BGA package. A 75MHz 6mm focal length transducer was used to create this image. This image displays information regarding the bond quality of the die top and lead finger interfaces. Disbonds between the encapsulant and lead finger areas can be seen. Disbonding in the lead finger area could likely prevent the bond wires from making a proper connection. Not only could infant electrical failure occur, but long term reliability could be impacted as thermal stresses cause the defects to grow.

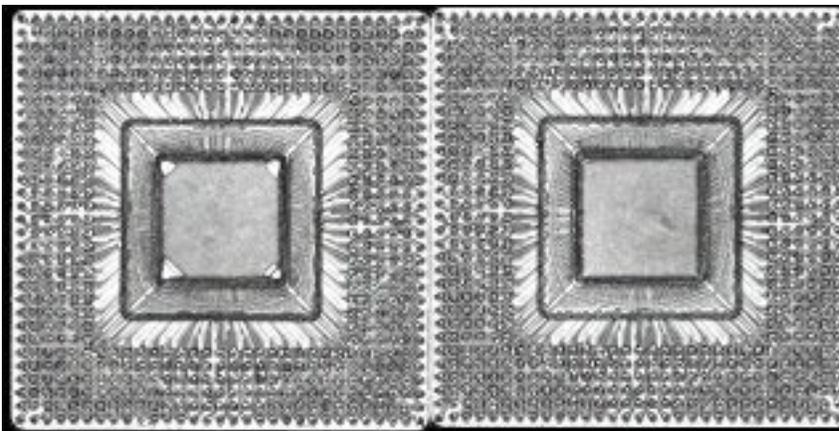
This is a pulse-echo (reflected) mode image also of the encapsulant or back side of a metal BGA package. A 75MHz 12mm focal length transducer was used to create this image. This image displays information regarding the bond quality of the die top and lead finger interfaces. Bright white areas representing disbonds between the encapsulant and die can be seen. Disbonding on the top of the die will cause the bond wires to not make an adequate electrical connection. Disbonding, noted by the yellow arrow, can also be found between the die attach and heat sink. This disbonding was likely caused by an insufficient amount of attach material, however, improper force in attaching the heat sink could also be a cause.

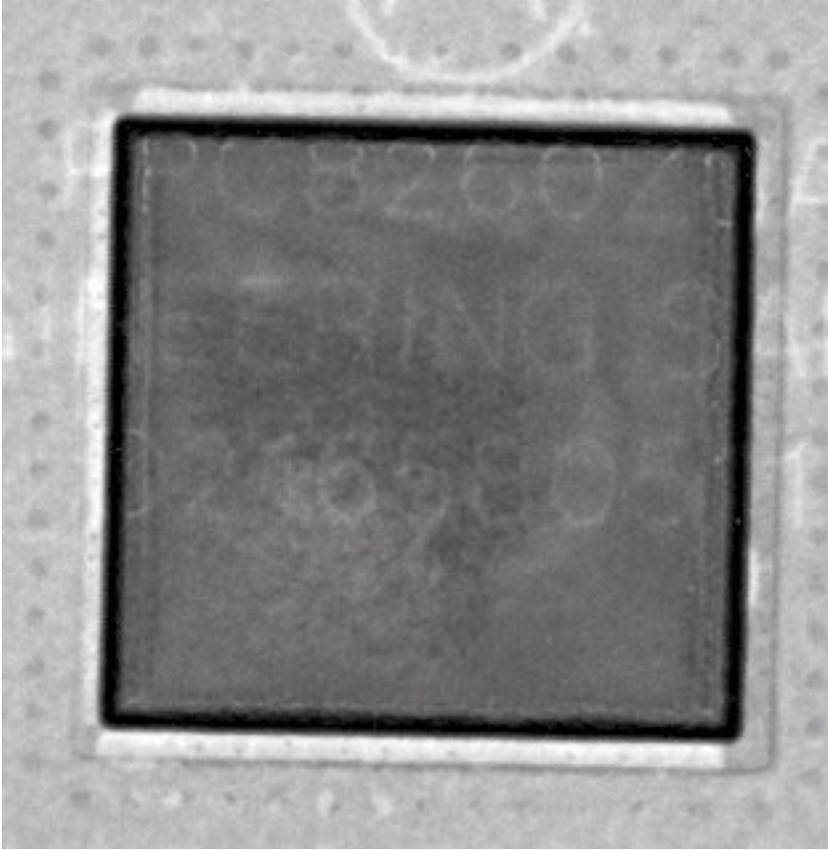
This is a pulse-echo (reflected) mode image of the top side of a metal BGA package. A 75MHz 12mm focal length transducer was used to create this image. This image displays information regarding the metal heat sink attach quality. Bright white area representing disbonds between the encapsulant and lead finger areas can be seen. Disbonding in the lead finger area could likely prevent the bond wires from making a proper connection.
