Miscellaneous Applications

Package Types:

Smart cards, composites, LTCC substrates,

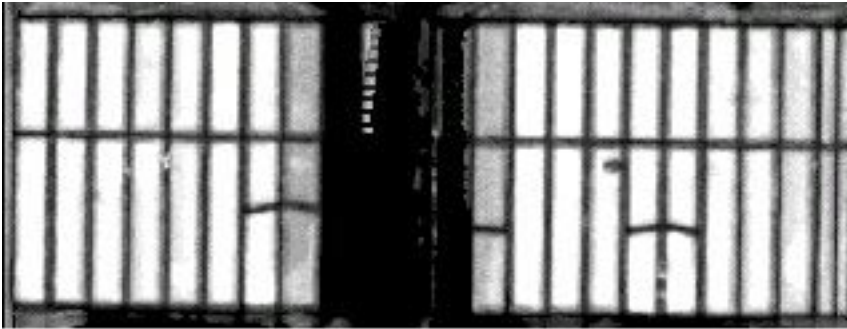
This is a pulse-echo image of a group of small piezoelectric (PZT) ceramic stripes. Each strip is used on a hard drive reader head. Black lines across several of the stripes indicate microcracks in the PZT material that were not visible optically. The

cracks were internal to the material and did not propagate to the surface. These cracks will cause the reader head to mechanically fail after stressing.

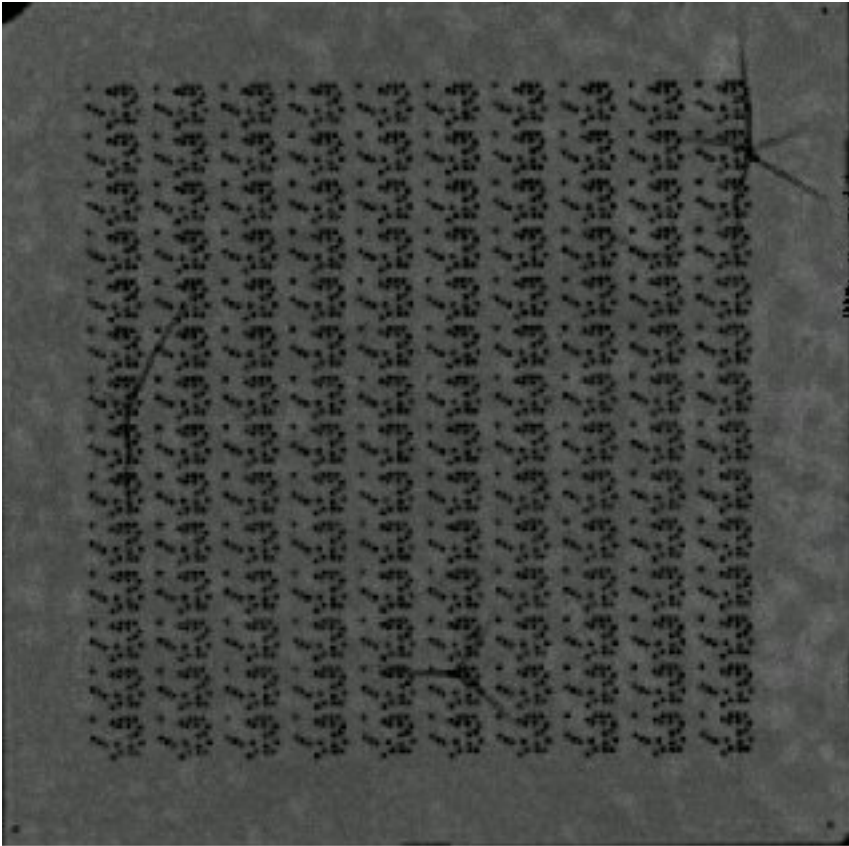
This is a pulse-echo image of a ceramic plate with laser machined holes. The image was generated using a Loss-of-Back-Wall technique. Black lines can be seen propagating from some of the holes. These are cracks as the result of an excessively long pulsewidth laser shot. Traditionally, Zygo or die-pentrate tests are performed to find these cracks, however cracks that don't reach the surface or are extremely small aren't seen in these test. SAM imaging identifies these cracks very easily.

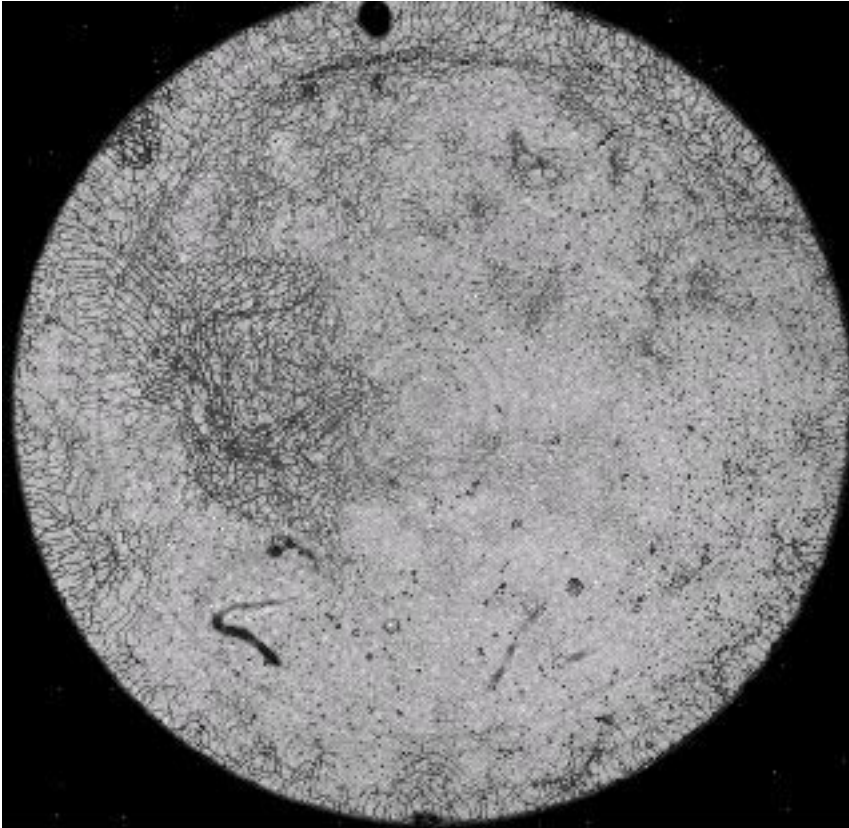
This is a pulse-echo image of a beryllium oxide disk. The image was generated using a Loss-of-Back-Wall technique. Black areas signifies voids or cracks within the disk as the result of a manufacturing process that allows air pockets to be trapped in the material as it is being fired.

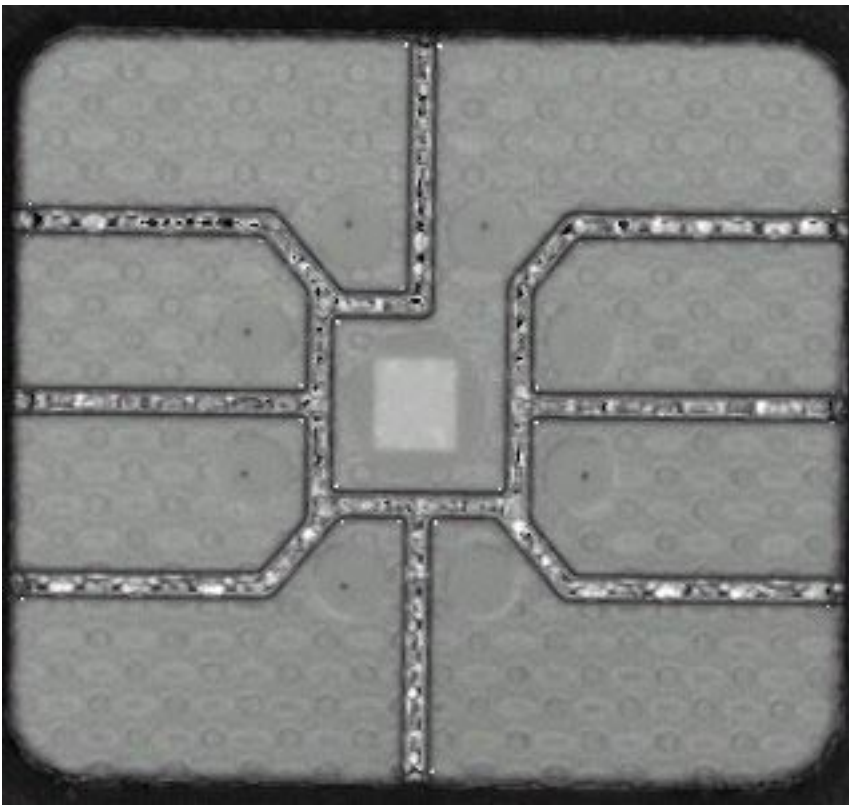
This is a pulse-echo image of a smart card. Small white areas in the square center can be seen. These signify die attach voids. Excessive void can mechanically and thermally compromise the device.
