Plastic Ball Grid Arrays

Application Overview:

The inspection of plastic ball grid array (BGA) devices using SAM equipment is very common. Failure modes such as moisture-induced cracking, or popcorning, and delaminations are the most common. Below you can see a variety of the types of defects that can be found with a Sonix SAM system. Automated inspections are possible, but most inspections are done in FA or process control environments.

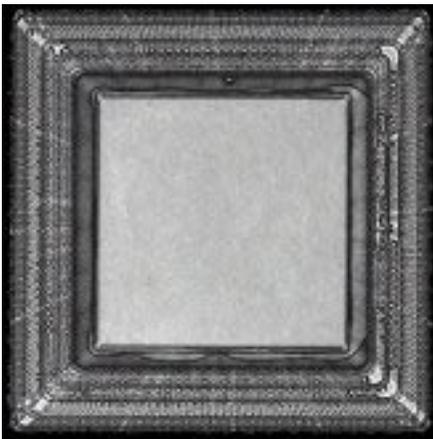
This pulse-echo (reflected) mode image is of a plastic encapsulated ball grid array device. The lower image is just a zoomed section of the upper image. In this inspection, concern was raised if excess die attach material, upon expansion, would wick up the side of the die and cause die top delamination. The coefficient of thermal expansion of the die attach material can cause a very small, but significant separation of the encapsulant material from the side of the die. If the excess material wicks up the side of the die too high, the delamination can propagate on top of the die, causing device failure. Research has shown that wicking in excess of 0.8 times the height of the die can directly lead to device failure. Acoustic inspection becomes necessary when a new process or material is used to ensure excess die attach wicking does not occur. Due to the vertical geometry of the wicked attach material, the height of the material can not be directly imaged acoustically, however a technique co-developed by Sonix and the packaging industry has shown a relationship between the base width of the excess material and the height of the attach material.
